PEPPERELL PAPER CO. DAM

MA 00373

PHASE I INSPECTION REPORT
NATIONAL DAM INSPECTION PROGRAM

Identification No.: MA 00373
Name of Dam: Pepperell Paper Co.
Town: Pepperell, Massachusetts
County and State: Middlesex County, Massachusetts
Stream: Nashua River
Date of Inspection: June 14, 1978

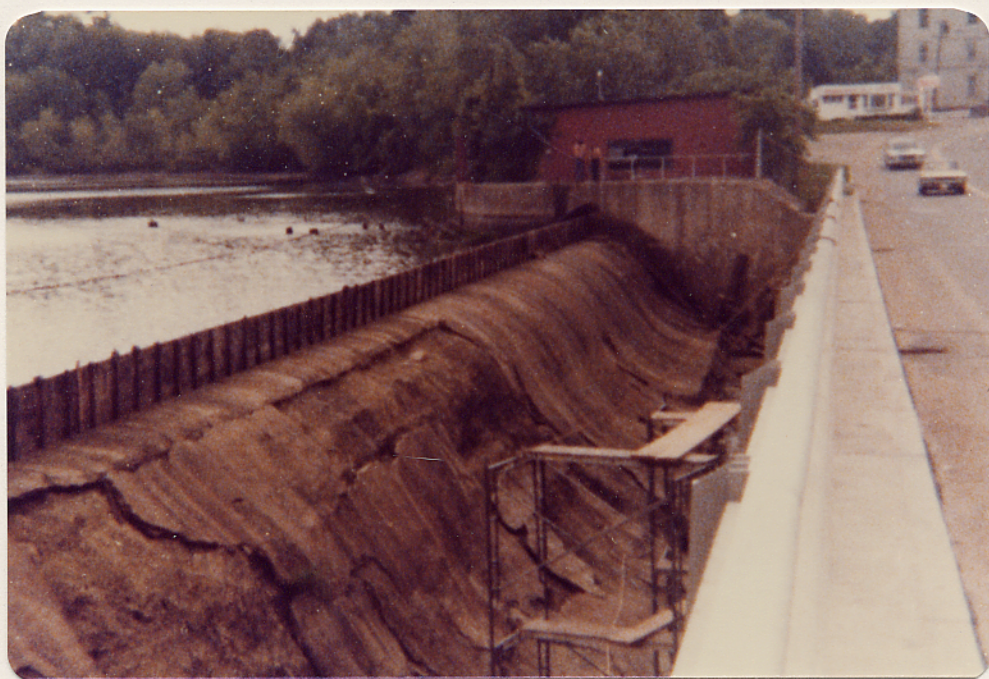
OVERVIEW PHOTO

a. General. A visual inspection of the dam was made on June 14, 1978. A copy of the inspection checklist is included in Appendix A. The concrete spillway section fills what was probably close to the normal width of the river at this point. A modern highway bridge crosses the downstream channel at about the toe of the spillway. The general appearance of the dam and appurtenant structures was in fair condition.

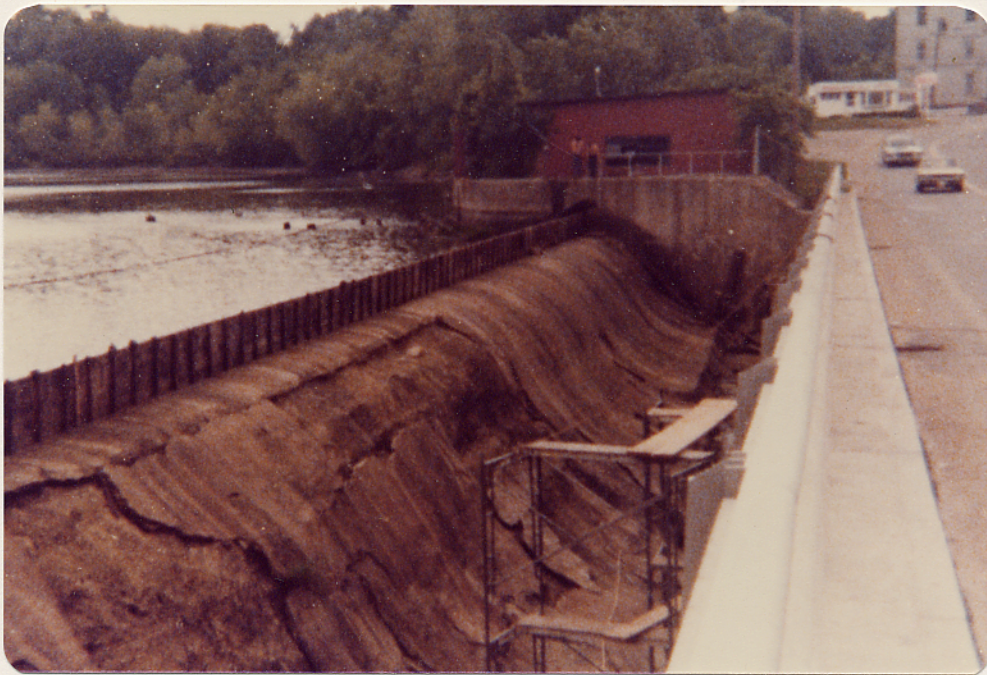
19

b. Dam. The concrete overflow section had many areas on the downstream face which showed major spalling and abrasion. At one time the downstream face was repaired by spraying with gunite. Many areas of the gunite have since peeled off with the reinforcement bars exposed. There is some undercutting of the toe. The abutments are integral with the surrounding natural grade and highway. On the event of overtopping, water would flow between the downstream side of the abutments and the upstream side of the highway bridge.

Downstream View of Spillway

The owner of the dam should develop and implement procedures which would include periodic inspection of the dam and the initiation of repairs, as required. Presently required maintenance includes repair of all spalled concrete and the application of dental concrete in the undercut areas at the toe of the dam.

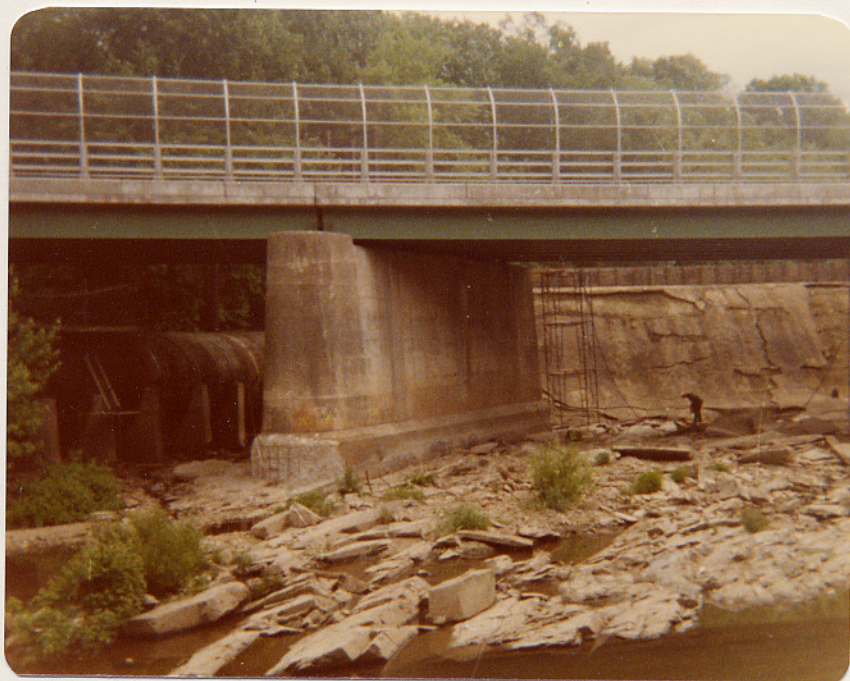
3

Downstream Face of Dam taken
from Downstream Channel

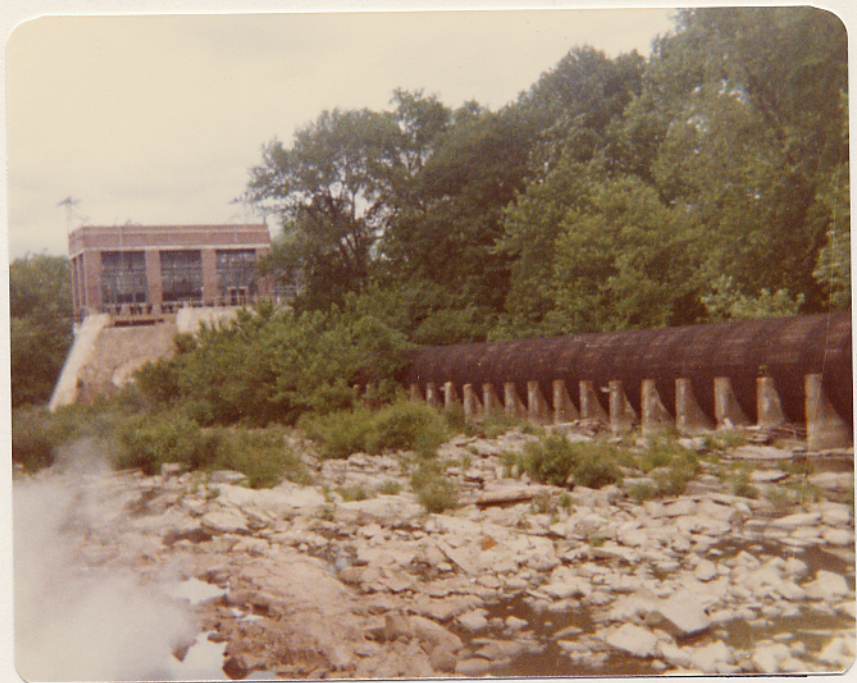
Downstream Channel and
13ft. Dia. Penstock

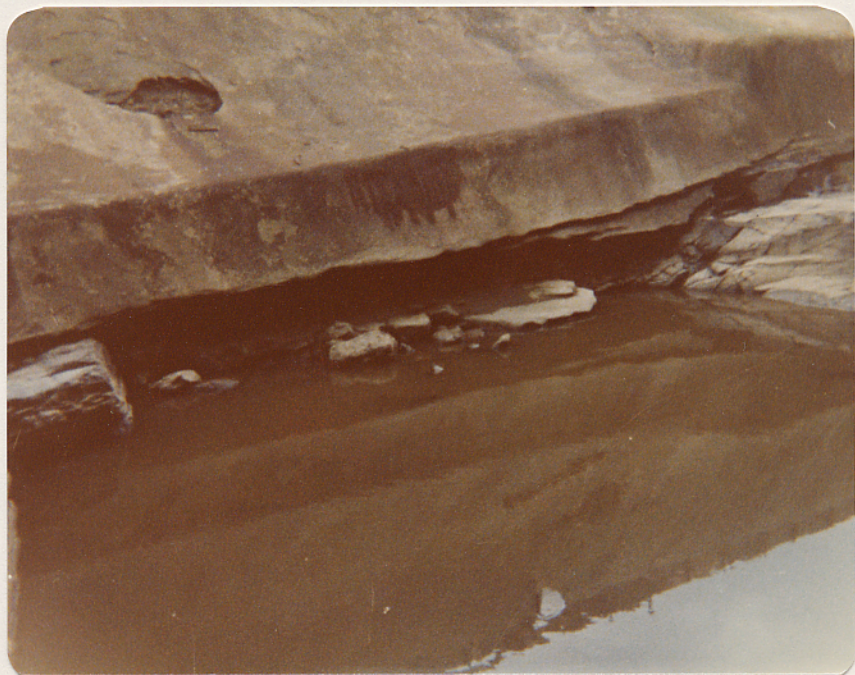
The dam is in fair condition with some spalling of repair work previously performed on the downstream surface. There is some undercutting at the downstream toe. The penstock and gate house are in fair condition. Part of the abutments would probably be the first sections to fail in the event of overtopping.

Downstream Toe of Dam

The seepage condition at the toe of the dam should be monitored by constructing an adequate collection system and weir.
